# REFORMER TUBES & COMPONENTS

Comprehensive services for testing reformer tubes.

# Reformer tube testing

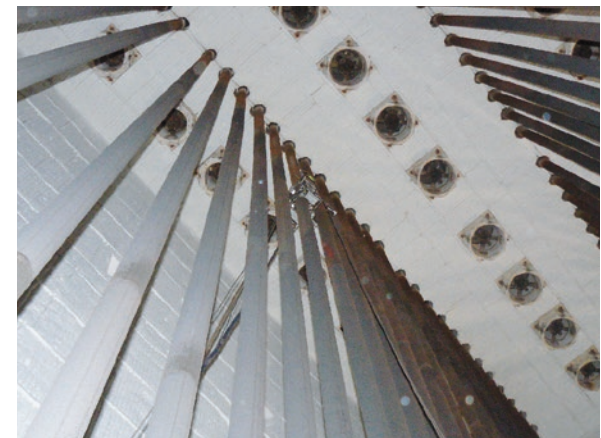
*Reformer tube testing with LEO-Scan*

For the purpose of inspecting centrifugally cast reformer catalyst tubes used in steam methane reformers, FOERSTER has developed and built the proprietary 'LEO-Scan' system, an inspection carried out from the outside of the tubes, using the Eddy current and Laser technique.

This is the only proven EC system in use today that penetrates the complete tube wall thickness up to 24 mm (0.95 in). As the crawler ascends the tubes, proprietary designed EC probes record signals for evaluation. Not only does the system record the variations in magnetic permeability, but more importantly, the system processes and continuously monitors it, thus allowing the EC system to detect cracks and defects within the tube wall and the surfaces of the OD and the ID. Since the system functions electronically, LEO-Scan requires no couplant (e.g. water), which makes the entire examination absolutely repeatable.

Using up to four lasers (depending on tube-to-tube clearances), the LEO-Scan measures the outside diameter at the same time as it conducts the EC testing. The lasers allow for maximum accuracy and repeatability. Tube diameter measurements, taken as a secondary procedure that has the ability to reveal normal creep, can also help point to the probable conditions that caused the damage.

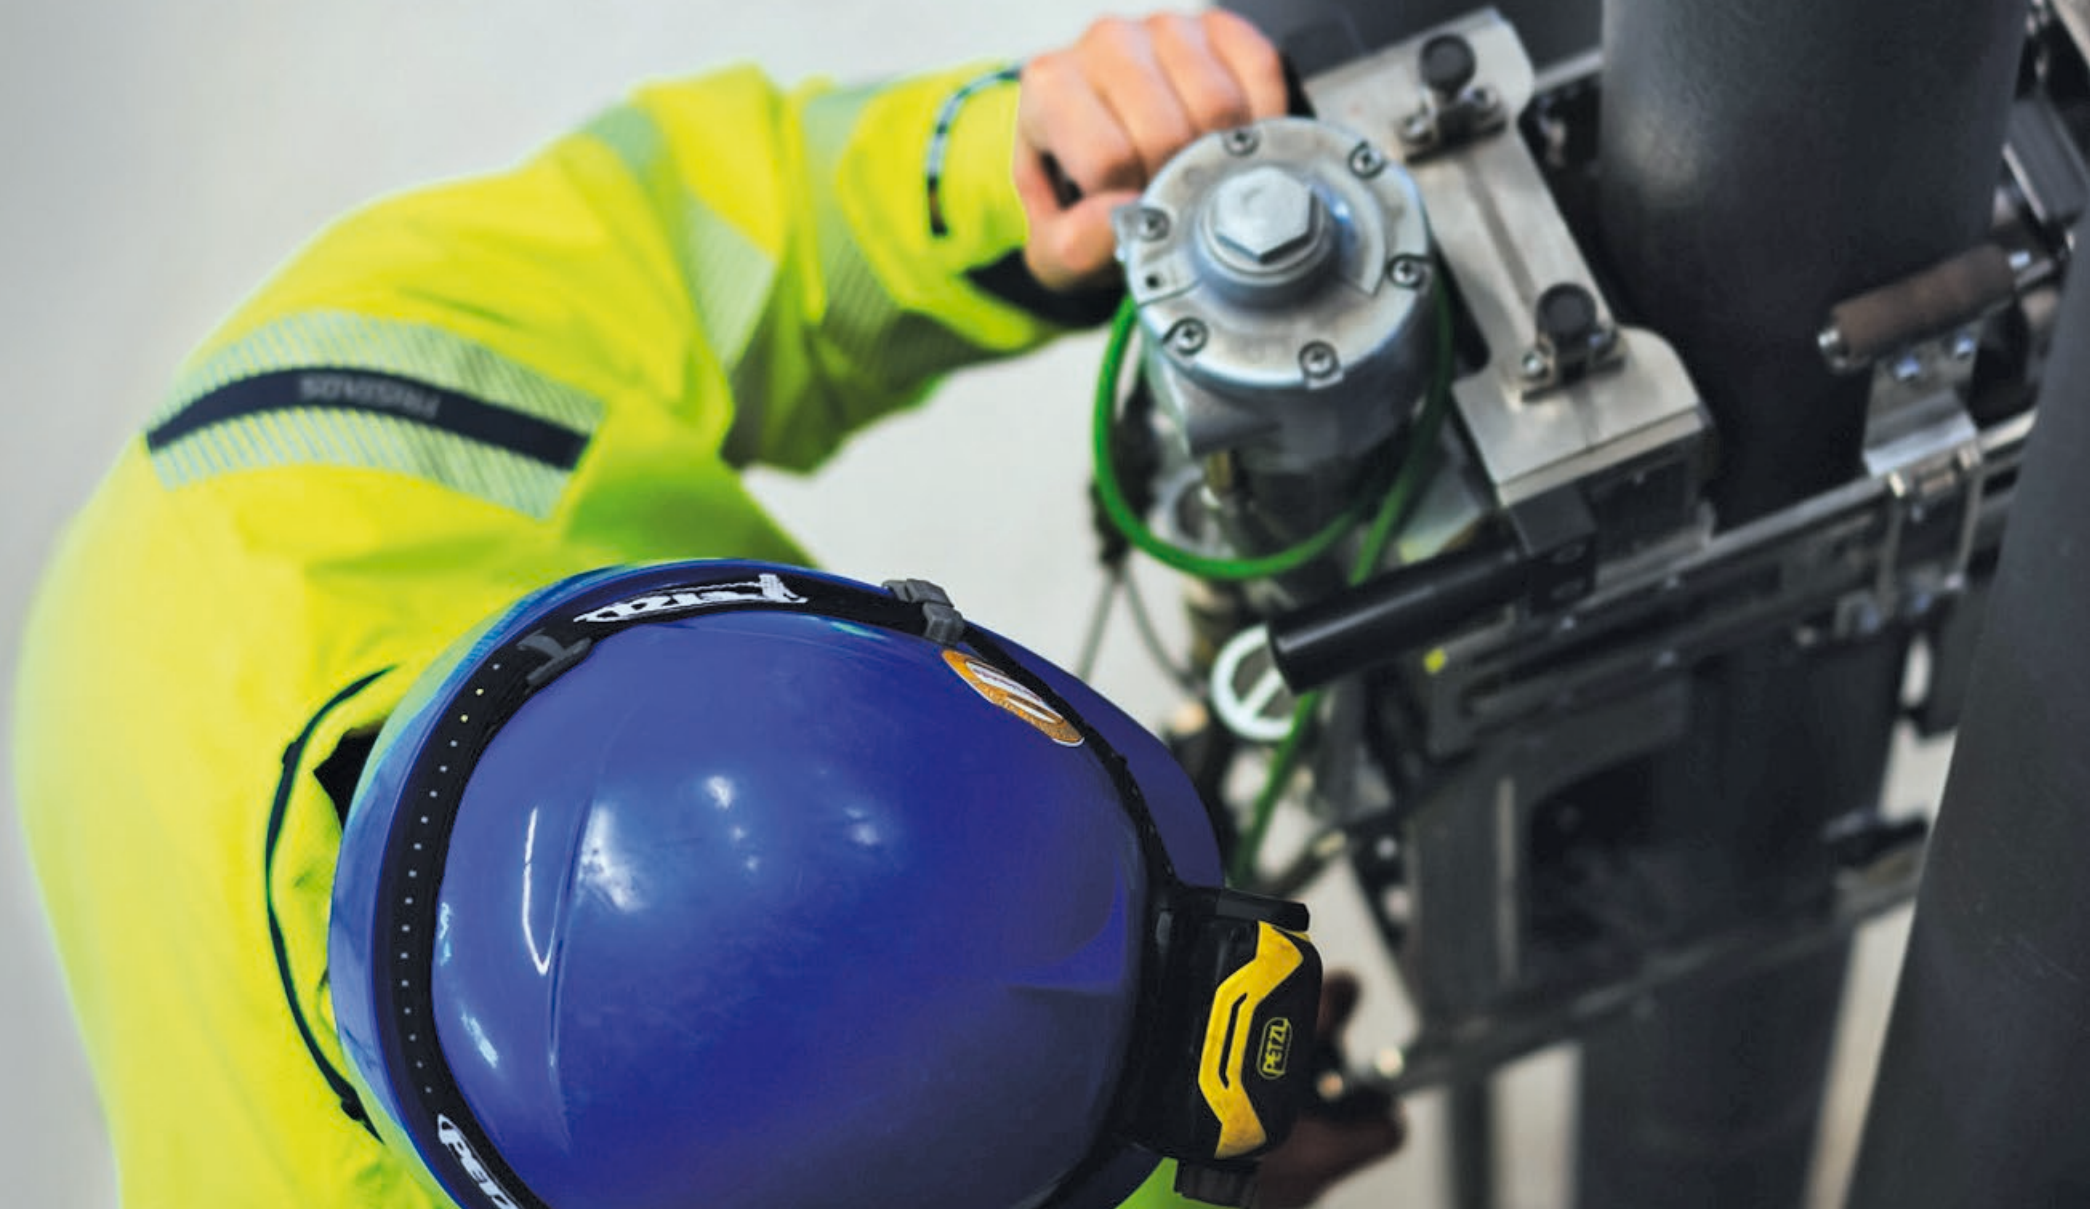
## External tube inspection (LEO-Scan)

The complete LEO-Scan system is mounted on a unique tube crawler. The special construction of the crawler transports the sensors from the furnace floor – depending on reformer design – all the way up to the roof. This includes the areas below the top of any flue gas collection tunnels, if present. The probes and lasers are mounted near the bottom of the crawler, allowing readings to be taken in the most critical areas of the typical down-flow reformer, since this is considered the hottest portion of the tube. The device is also intended to test reformers with tube-to-tube clearances as narrow as 20 mm (0.79 in). This allows the inspection of furnace designs with very tight clearances from the OD. Other crawler and probe configurations are also available to test up-flow reformers. No cleaning of the tubes is required.

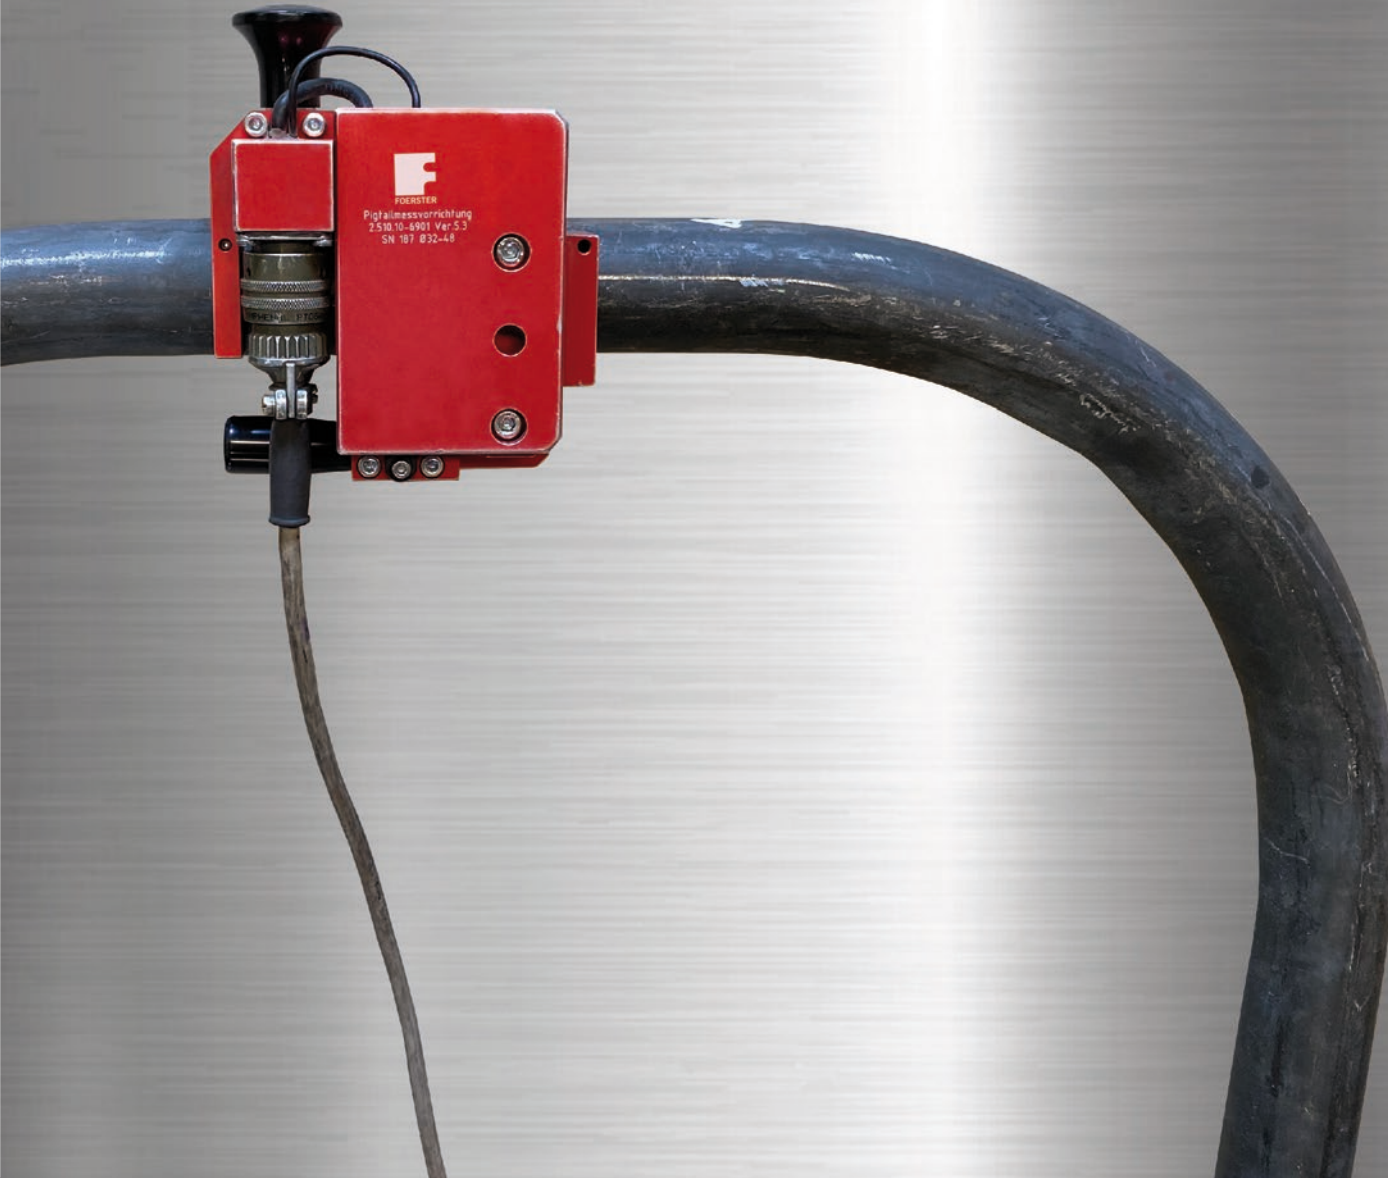
Wrought outlet pigtails are critical components that need rigorous inspection due to their location and intended function. For the identification and determination of creep, we have developed a unique device for measuring pigtails diametrically from the tube outlet to the manifold.

The measurements are taken on two axes; this configuration enables evaluation of diametrical growth of both the straight pigtail sections and the bends, taking into account the inherent (and normal) differences in diameter due to the bending process. Compared to manual gauge testing, this new system is very fast, reliable and repeatable. It also provides an accurate diameter profile over the complete length of the pigtail, resulting in an assessment of creep in digital form that can be used for future evaluations.

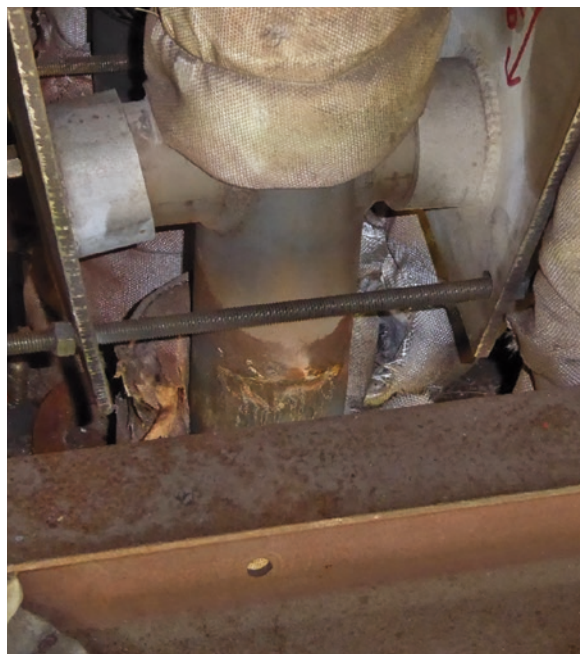
Figure 4: Typical top end

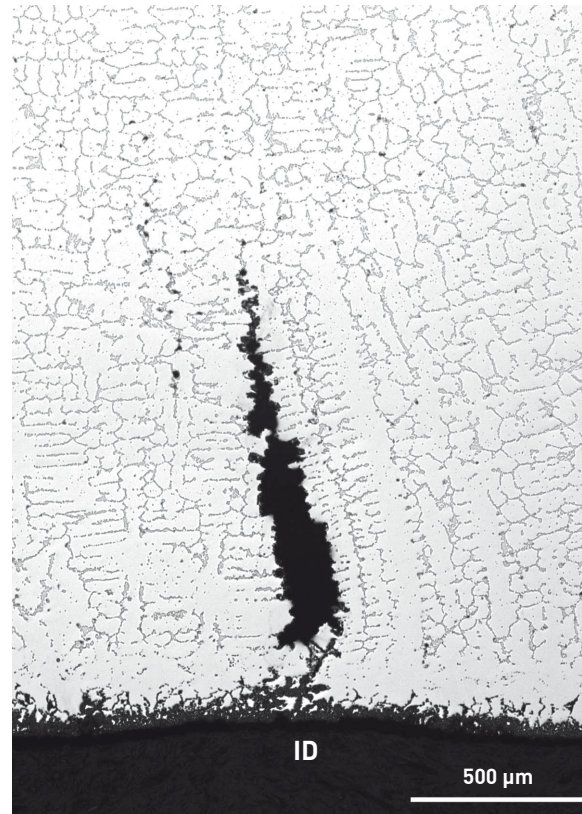
Figure 7: Higher magnification photomicrograph of creep fissure

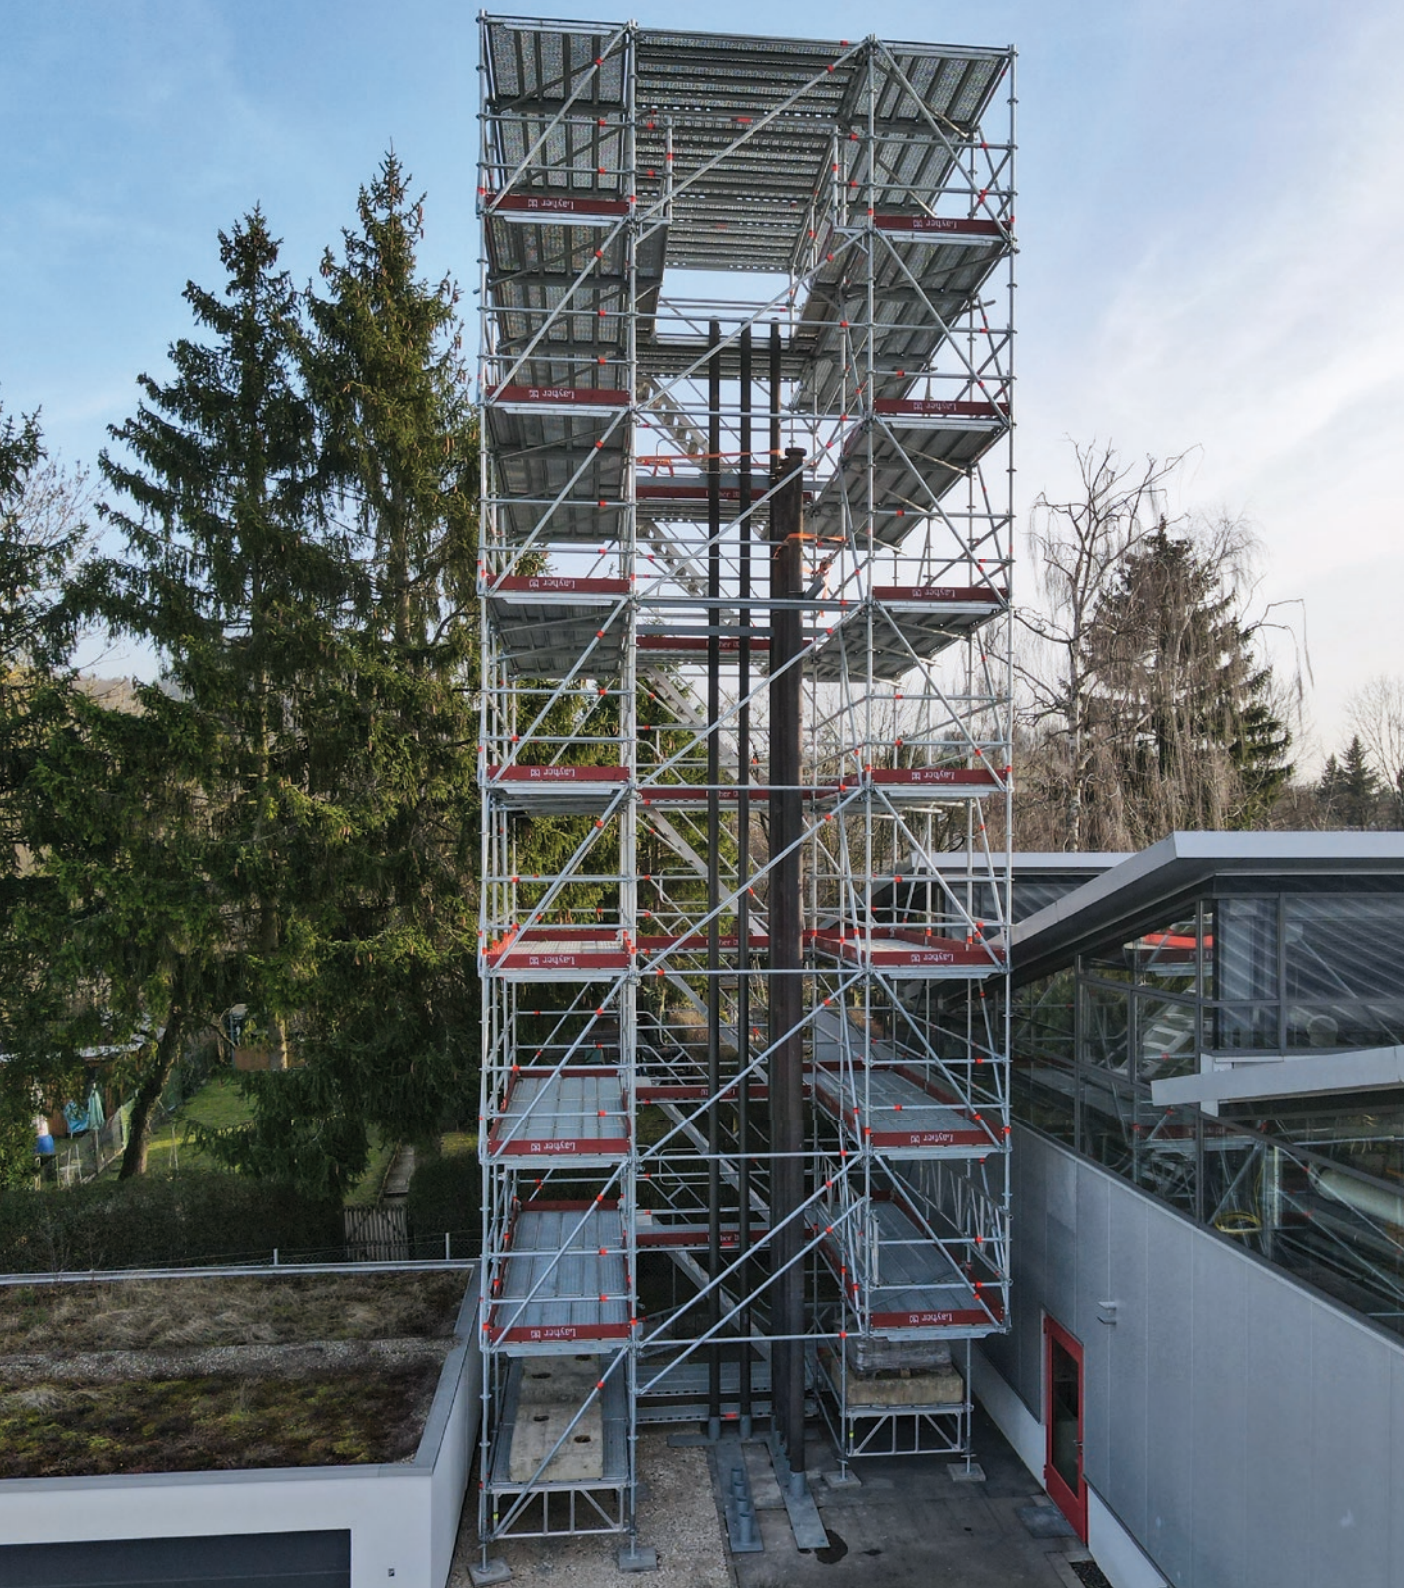
**The FOERSTER test tower – Our true-to-life test facility for putting test equipment through its paces**

The newly installed test tower, which contains several tubes in their original vertical extension (including the top flange), is a perfect representation of a catalyst tube row in a steam methane reformer. This configuration allows for realistic scanning conditions to trial new developments or optimize prototypes and modifications; it is now available for experiments with automated external (OD) and internal (ID) scanning systems. Furthermore, it is ideal for testing the software side in terms of applying control and data-collection programs in real time when using advanced EC mobile instrumentation.
